Detonation
Pipeline
Chlorine
Hydrogen
Ferric chloride
Tracing system
Corrosion
Lock-out
Maintenance

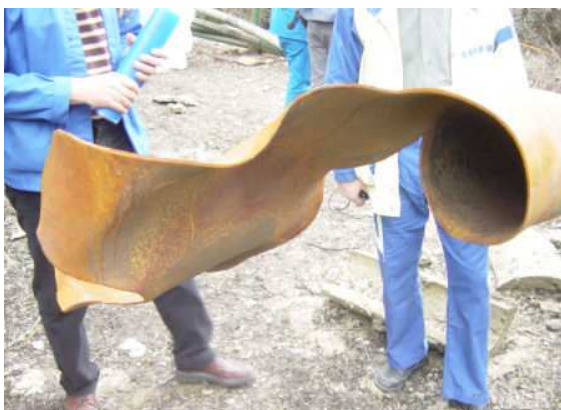
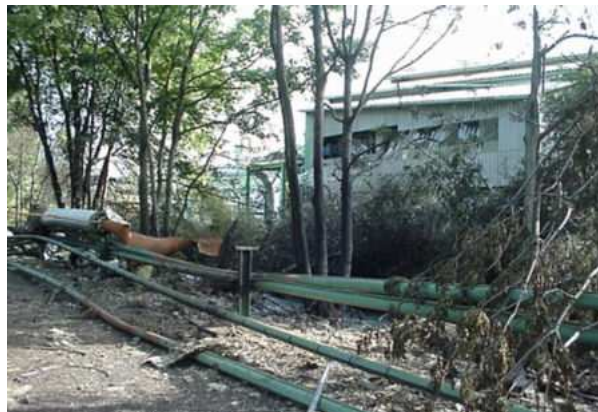
Near the rupture zone closest to the manufacturer site, the immediate environment was covered with a dark red powder mainly comprising ferric chloride ($FeCl_3$) contained in the passivation film of the pipeline.

The damage recorded (helical shaped fragment, pressure wave, etc.) confirms the explosion's detonating nature.

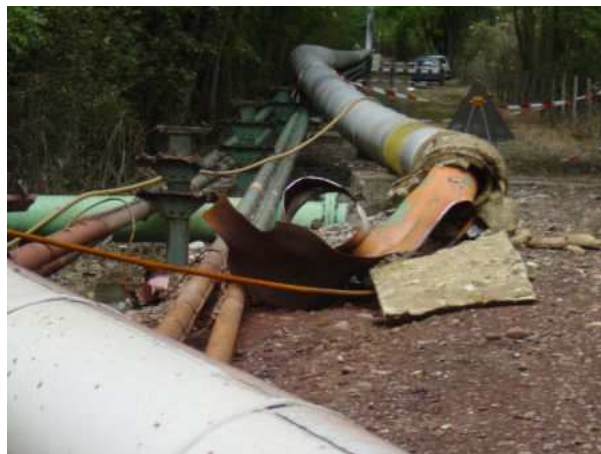
An incident in **April 2001** (branch connection left open during rainy season while the chlorine transport line had been placed in a trough during the replacement of an insulation valve of a pressure sensor) allowed humidity to enter and hydrate a part of the ferric chloride contained in the passivation film. This hydrated ferric chloride was deposited in its solid form in the operational pipeline between April 2001 and May 2005.

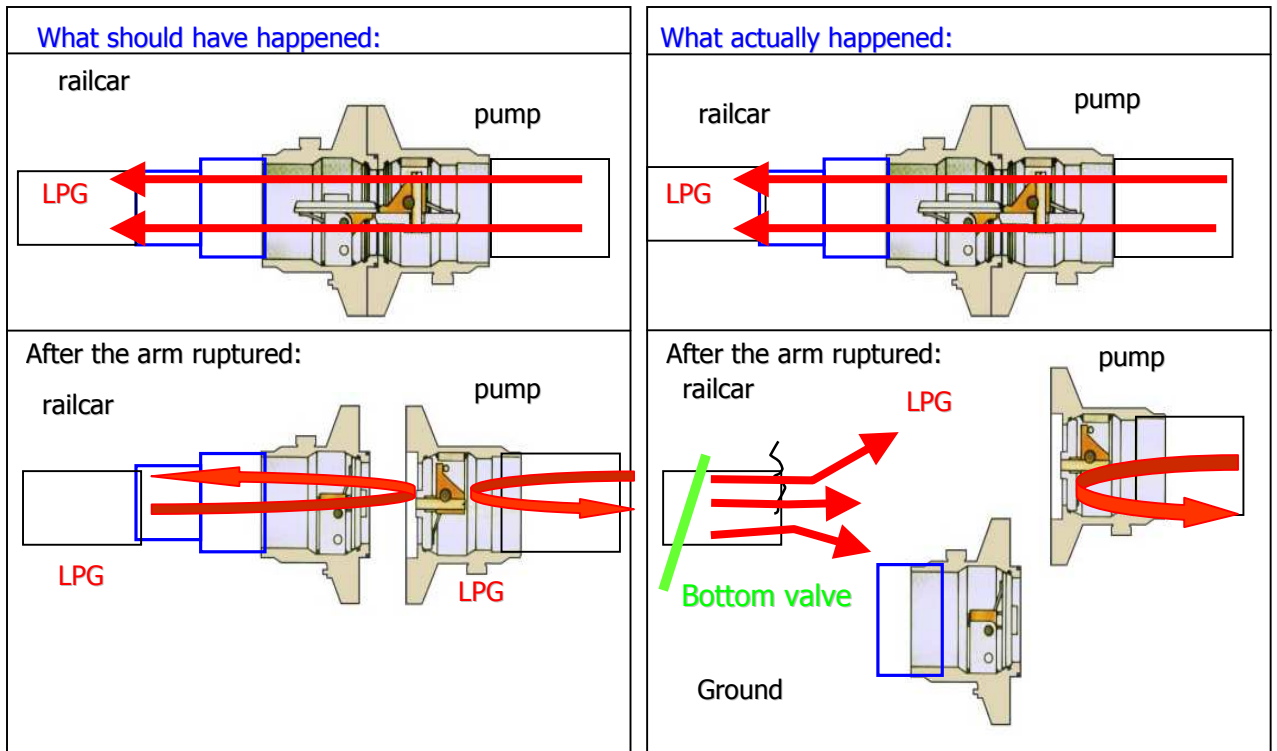
Railcar tank side

The severed coupling

Furthermore, the coupling ruptured on the railcar side. The expert assessment conducted on this element showed an insufficient original thickness and extensive corrosion.

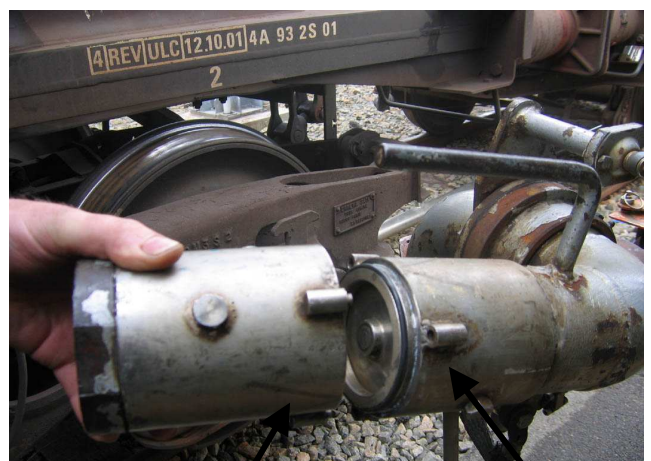
Pump side

Valve found on the ground

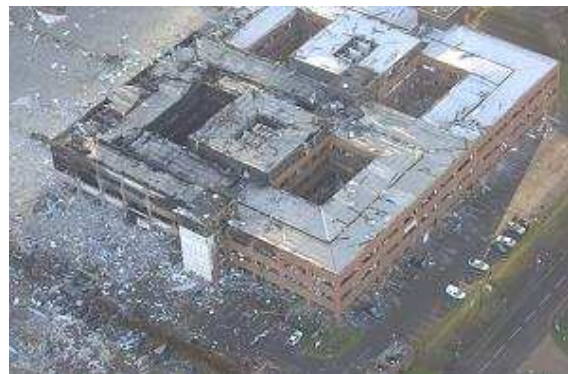
Photograph 1: Devastated building at the terminal site

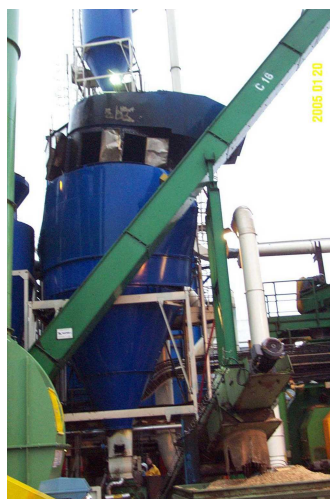
Material losses were evaluated at 250,000 euros, attributed to the replacement of the refiner (at the origin of the accident), and the damage caused to the sorter and cyclofilter. The silo and cyclofilter vents also have to be replaced. The plant also reported 750,000 euros in production losses due to the production line being shut down for two days.

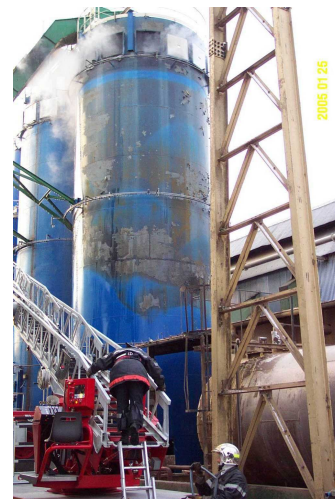
The consequences were minimal in comparison to the first accident. The production shut-down was limited to 14 hours; the storage silo's explosion vents and electrical cable that melted during the fire must be replaced.

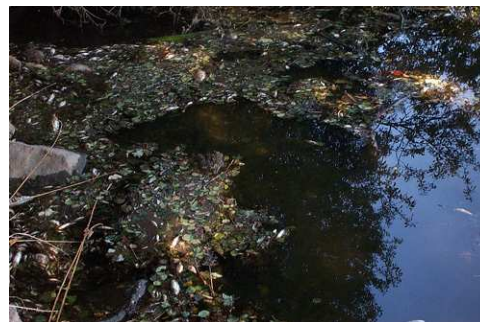
Photo DRIRE Auvergne

- ✓ according to the plant operator's estimate, approximately 20 m³ of effluents containing cyanides at a concentration of 3 to 5 g/l was released into the Cher River,
- ✓ fish mortality (approximately 2.5 tons) was reported by agents of the National Commission for Fishing,
- ✓ no health problems were reported by residents living near the site or near the point where the effluents were released into the Cher.

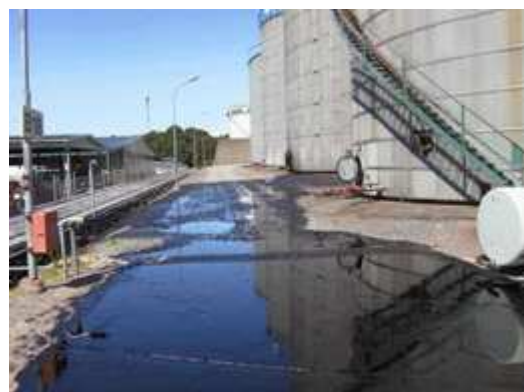
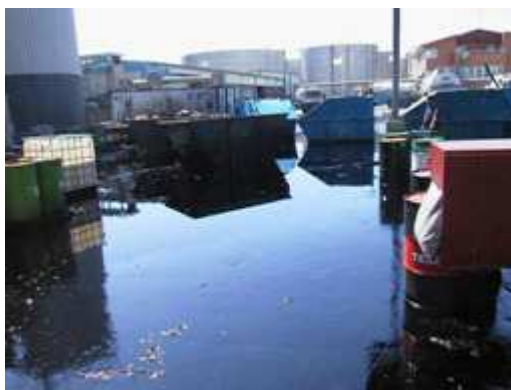
Photo: the insurance company (21 June 2003).

Oil spill outside tank No 375 was spread on the surrounding ground. Under the pipe rack (in the left) there was a rain water drainage sewer.

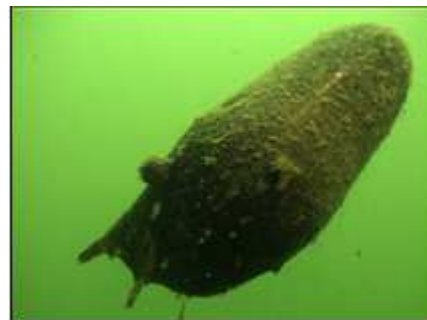
*The oil formed clusters that did not float on the water.
The diameter of the clusters was 3 to 10 centimetres.
Photo: Swedish Coast Guard.*

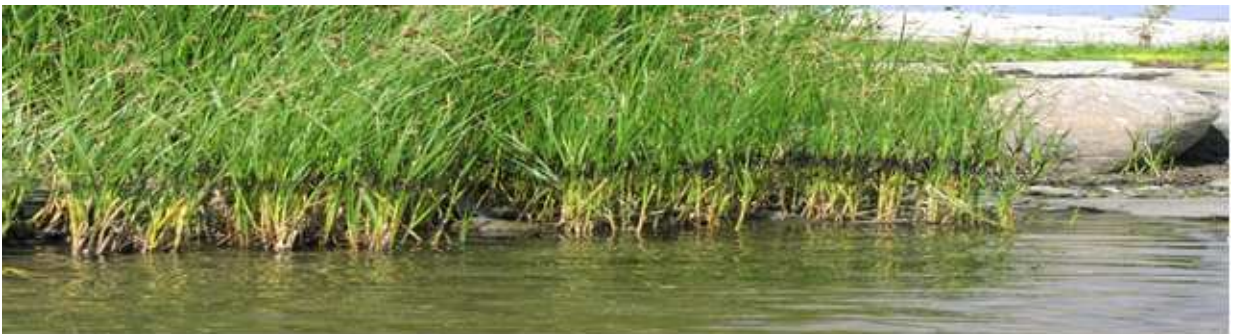
Photos: Stefan Larsson, West Water enterprise.

Environmental consequences of the spill of heavy fuel oil in the oil harbour.

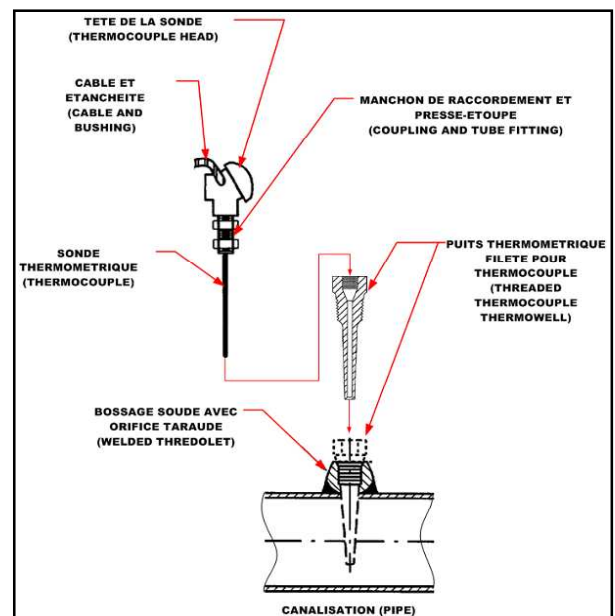
Temperature sensor assembly diagram

The analysis of the incident discovered that the thermocouple was improperly installed on the bottom circuit of the raffinate stripping tower. The installation was not in compliance with the construction drawing of a thermocouple well on a pipe.

The investigations conducted following the incident showed that the thermocouple had been installed without a "sensor pocket", thus without protection. The hot raffinate was thus in direct contact with the sensor. As the quantity of product was excessive and the fluid very hot (320 °C), the tube fitting was unable to properly maintain the seal, leading to self-ignition of the product released and in contact with the air. The equivalent diameter of the break at the pipe level is roughly 10 mm.

1. A threaded boss on the pipe wall intended to receive the thermocouple;
2. Screwing of a "sensor pocket" on the aforementioned boss and reinforcement by means of a weld bead;
3. The thermocouple is then screwed into the pocket;
4. The wires are connected to a signal transmitter, once the cable is connected to the sensor by means of a coupling.

In this configuration, while ensuring a reliable temperature measurement, the thermowell guarantees that there will be no direct contact between the process fluid (for which we are attempting to measure the temperature) and the thermocouple. In the case of accidental rupture (contact between the process fluid and the thermocouple), the tube fitting limits/prevents the loss of confinement provided that the leak is not excessive.

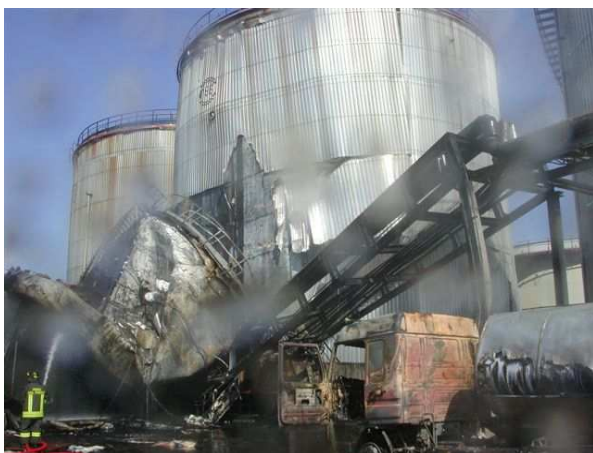
Fig. 2

The missile-tank exploded fell down on a 2nd bitumen tank (TK166) of 8000l of capacity. The missile roof entered in the TK166 shell, then squeezed itself into the TK166 basin (Fig. 2,3).

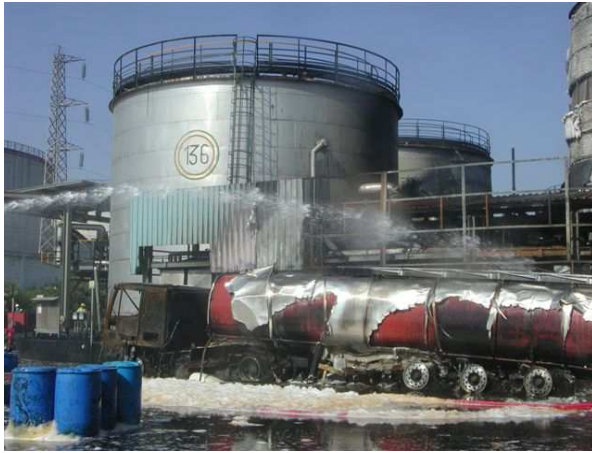
Fig. 4 Photo DR

Fire was handled through water and foam, while tanks and browsers involved were been cooled (Fig. 4, 5, 6).

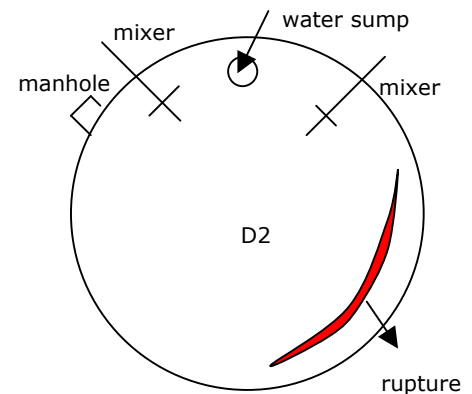
Figure 3: Schematic view of the bottom of storage tank

In this band the bottom of the tank formed a gutter. In this gutter uniform, internal corrosion was found and no pitting corrosion.

The bottom plates showed no external corrosion in the long, small band. The other bottom plates indicated no extreme corrosion.

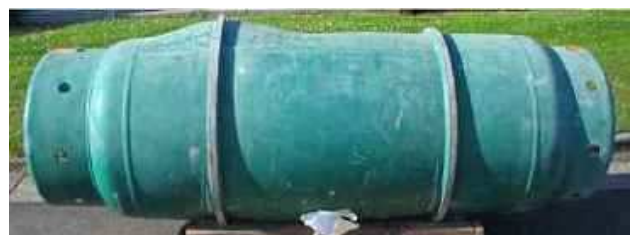
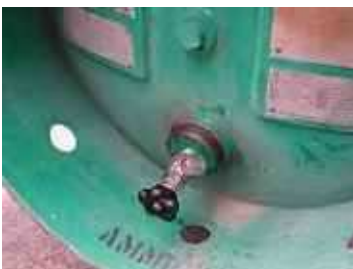
The tank was equipped only with filling and drainage valves and was not equipped with any pressure accessory such as a "pressure gauge" or "safety valve" (see photo).

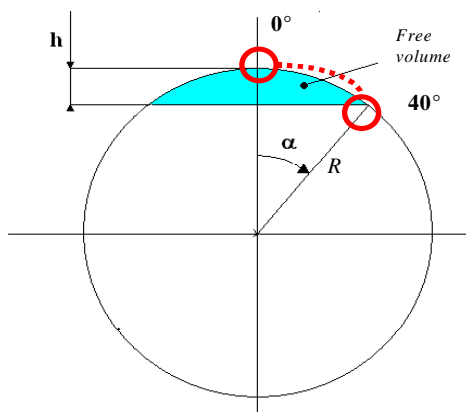
The coefficient of 85% is obtained by aligning one of the 2 painted marks with 40° angle on the side of the tank. The operator can thus position the eduction pipe (built into the tank) allowing the NH₃ to discharge before the entire available volume is filled up. The tank's positioning is thus extremely important as shown in the following diagram:

It was noted that, due to the design, the end of this discharge tube is a variable distance from the cylinder wall: It cannot thus fulfil its role with precision.

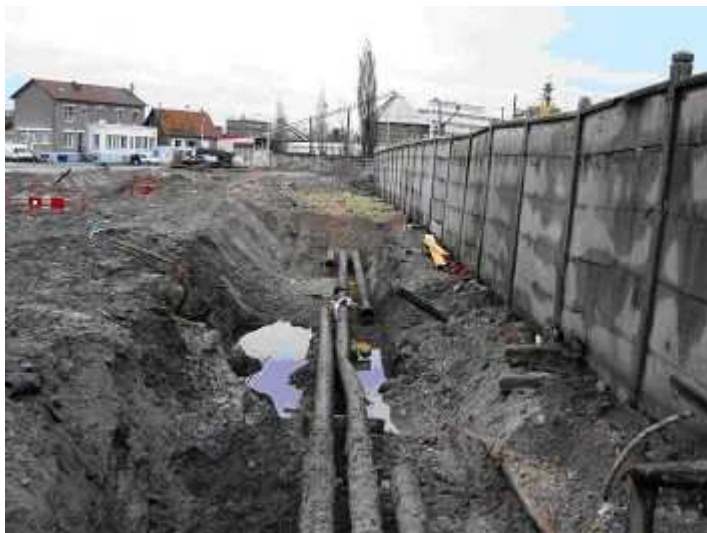
Photo operator

✓ Nearly 370 m³ of gas oil was spilled on the stretch of land being dismantled. The hydrocarbons seeped into the soil to reach the water table that is 4 meters deep. However, no immediate or medium term pollution was observed in the neighbouring docks of the Seine. Pumping equipment was set up by the various players involved and the operation was coordinated by the fire department right from the afternoon of 15 December on the site being dismantled and in the nearest drainage network. On the evening of 16 December, the pumping equipment helped in recovering 55 m³ of spillage. About three months following the accident 70% of the products had been recovered.

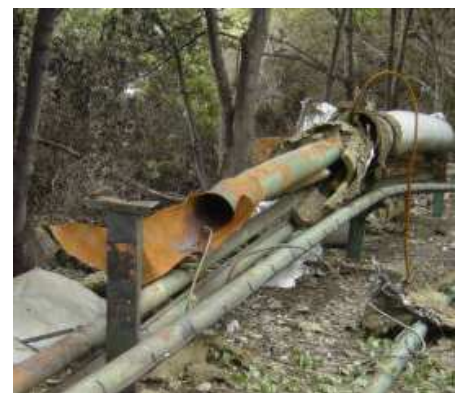
In fact, the proportion of hydrogen (20%) released in the gaseous chloride contained in the pipe, which was capped at each end and kept at low pressure (0.25 bar), formed an explosive mixture requiring very little initiation energy to ignite (in the order of a dozen microjoules or so).

The operator cleaned the inside of the structure (2.5 to 3 t of mineral and organic residues were extracted), and had planned to install temperature sensors every 500 m with upper and low safety devices, refurbish and secure the electric (heating) tracing, and perform regular endoscopic inspections...

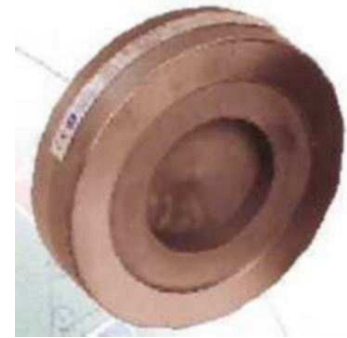
The primary compressor was unable to stop due to partial clogging of the pressure increase regulating gauge ($P_{\text{measured}} < P_{\text{true}}$). The valve malfunction was attributed to a maintenance error: the valve had been replaced by an inappropriate model (Calibration pressure > 310 bar). The fouling of the MPR section resulting from several days of production without being purged of greases accentuated the pressure increase kinetics.

The check valve, obstructed by low polymers was cleaned and checked, the safety PLC and the primary compressor's standby sequence were tested. The rupture disk and valve were replaced. Other measures were also taken: shut-down of the compressor in automatic or manual mode with a fail-safe pressure measurement, review of grease cylinder operating rules to prevent clogging of the MPR, additional training for the personnel, and consideration of this clogging phenomenon in the installation's danger study.

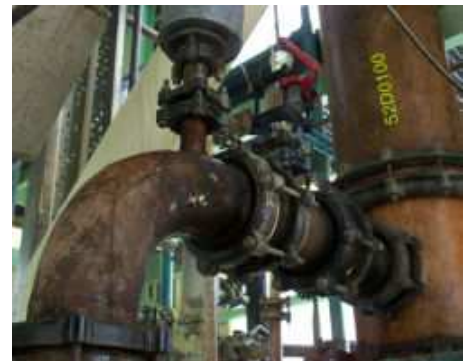
Sulphur dichloride leak in Catenoy

In a chemical plant, a sulphur dichloride leak (SCl_2) occurred on a pipe equipping the distiller of a distillation column hydrolysed causing a significant release of hydrogen chloride (HCl). The column was located in a metal building forming a sort of confined space.

The accident occurred during maintenance on a pressure sensor. The sensor had been identified as faulty after indicating a pressure of 108 mbar on the distiller's outlet (upper alarm threshold = 100 mbar), thus triggering the closure of the SCl_2 supply valve and the steam control valve of the distiller's heating system. Before replacing the sensor, the distiller containing 50 kg of SCl_2 had to be drained after the discovery of glass from the downgraded distillation column. This clogging had been identified 3 weeks earlier without any action being taken. In addition, the pressure sensor's shut-off valve, which could not be removed due to seized bolts, could not be closed; the operator was required to remove the entire assembly, thus leaving the ND25 branch connection exposed to the open air. As the sensor was not fail safe, when disconnected electrically the steam control valve opened and the distiller heater, whose temperature rose from 24 to 120°C in 30 minutes, resulting in the release of SCl_2 .

The measures taken with regard to the feedback notably concern the monitoring and intervention procedures in downgraded mode, the "failsafe" principle on the unit's entire functional safety chain...

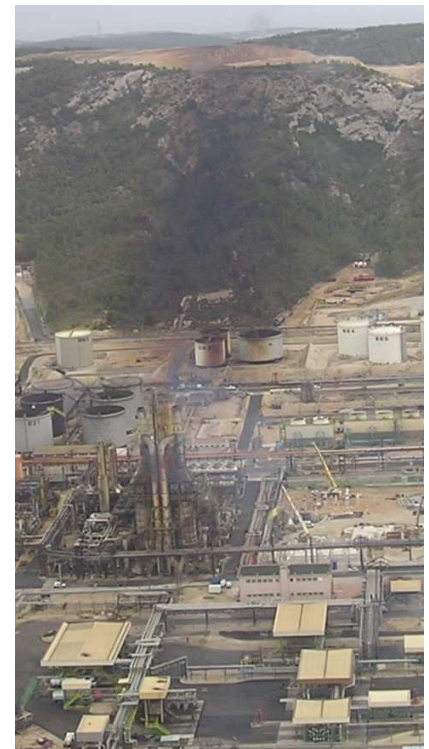
The operator analysed the accident and the initial measures were taken: installation of a pressure sensor on the tower head to shut down the furnaces in case a high pressure threshold is met, shut-down of heating and closure of furnace supply line valves (shutting down the tower supply line) the pressure drop threshold in the column is exceeded (upper threshold difference between the pressure at the base and at the head of the tower). Costs of cleaning and compensations raised 1.7 million euros.

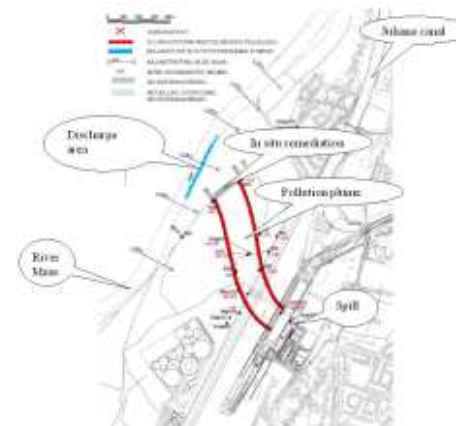
A broken pipe on a harbour-based petrochemical site released 3,000 m³ (2,100 t) of methyl-tertio-butyl-ether (MTBE) causing substantial soil and water pollution. The nearby Meuse River was also concerned; its water is pumped for human consumption and operations had to be shut down. A major clean-up installation was installed following the spillage.

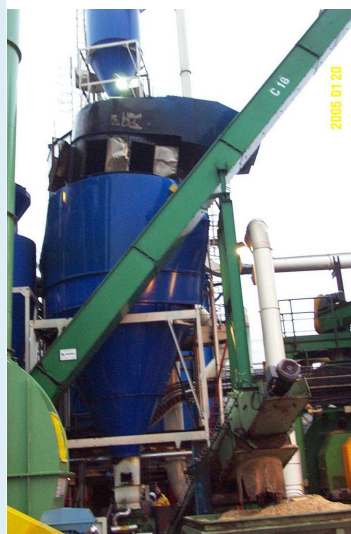
The firefighting water was recovered in a catchpit, then analysed and treated. The chips burned in the fire were disposed of in the plant's boiler but property damage (refiner, cyclofilter, sifting screen, vents, and the refiner's suction system) was estimated at 250K euros and the shutdown of the production line for 36 hours resulted in 750K euros in production losses.

The site's accident procedure manual proved efficient. According to the accident report, a metal part in the refiner had broken, causing sparks which caused the refiner to explode. The operator foresees to uncouple the refiner from the rest of the installations; a third-party expert evaluation of the installations, safety systems and intervention procedures; a thermal imaging camera to check the installations before, during and after an accident and an increase in the surface area of the cyclofilter vents (although already in compliance with current standards). Just five days following this accident, a smouldering fire caused a new fire in silo A.

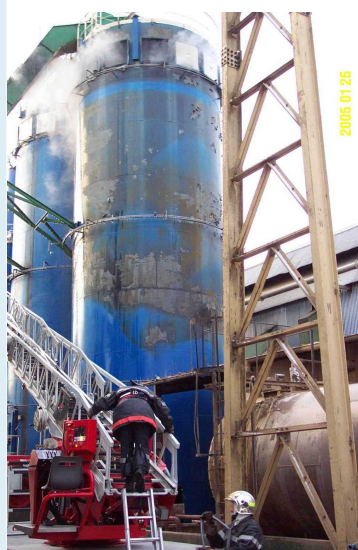
ARIA 29011 - 25/01/2005 - Haute Saone (70) - CORBENAY

The incident opened the silo's vents and projected dust and flames onto the adjacent production building. The fire spread via the electric wires before it was contained by the building's sprinkler system and extinguished by the emergency services. A thermal imaging camera was used to check for residual hot spots in the silo and emptied silo B, which had caught fire 5 days earlier, in order to perform the same tests. A site fireman monitored the installations until noon the following day. The firefighting water was recovered in a catchpit, then analysed and treated. The shutdown of the production line for 14 hours resulted in production losses estimated at 45K euros.

The silos vents had to be replaced and the production building's electrical installations repaired. According to the accident report, smouldering fires had remained after the fire of January 20th under the extraction unit, a 2-ton piece of bell-shaped equipment at the base of the silo. During this fire, the reservoir had been emptied, flushed and cleaned but this piece of equipment had not been raised. The operator initiated a third party expert evaluation of the installations, safety systems and intervention procedures, and the use of a thermal imaging camera to check the installations before, during and after an accident. Further more, the operator also modified the intervention and silo restart procedures; in the event hot spots (embers) are detected, the extraction unit will be raised for cleaning.

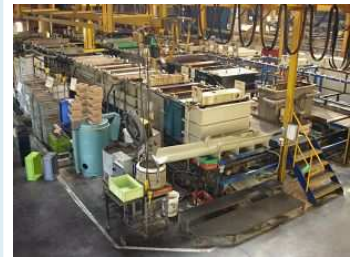
Informed of the incident at his home, the plant's safety supervisor requested the operator to close this installation (shutdown of the heating system) and to leave the bath in the retention area. The incident was recorded in the appropriate logbook. At 5 am the next morning, at the start of his shift, an experienced operator (15 years experience in metal surface treatment) noted that the retention basin was filled with a liquid and, after referring to the logbook entry on the anomaly, decided to transfer the product with a mobile pump into the cyanide alkaline discharge tank of the detoxification station. Due to handling error, he accidentally transferred the liquid into a reservoir on the detoxification line of the chrome plating baths, which are not adapted to processing such effluent.

At 9 am, the head of plant security verified, like each morning and by means of colorimetry, the pollutant concentration levels of river discharges and noted excessive cyanide content (> 2 mg/l); the shutoff valve on the sewer outfall was immediately closed. The cyanide concentration of effluent discharged into the Cher River was estimated by the operating company at 3 to 5 g/l. For the rest of the day, the detoxification station was cleaned but not entirely (specifically, the filter press was left as is), and the next day's discharge was once again polluted with cyanide when service was restored. Between 2 and 3 tons of fish were killed by this pollution. The total quantity of released cyanide was assessed at 70 kg. The Classified Installations Inspectorate conducted an investigation, discovered the failure to respect certain guidelines of the prefecture's operating permit (non-declaration of accidents, absence of safety instructions) and proposed that the Prefect issue a default notice.

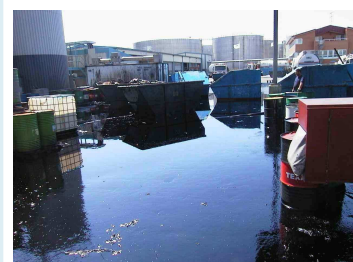
ARIA 32890 - 21/06/2003 - SUEDE - NC

The major factors which contributed to the accident were a lack of communication between the 2 shifts at the shift take over, absence detailed check lists for tank preparation and start-up process and of the equipment double-check before start-up, and the failure to respect operational procedures. Due to the Midsummer Eve holiday there were less personnel in the Oil Terminal than usual. The shift foreman was on vacation and the terminal manager had taken over the foreman's work. The wide consequences of the accident were caused by the wrong reaction of the employees who assumed there was some problem with the incoming flow but didn't go out and inspect the tank, the failure to respect the emergency plan which specify that the harbour should be informed immediately and the absence of bund and valves in the rain water drainage system. Moreover, the water drainage systems and booms were less efficient because of density of the product (higher than 1).

After this accident, the operational procedures, emergency response, organisational related areas, communication and design of the harbour were improved.

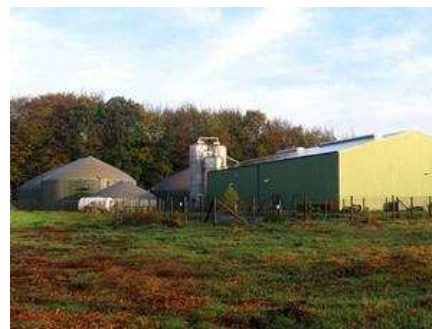
During the production of biogas by means of an organic waste reclamation process, a release of hydrogen sulphide (H₂S) killed 3 employees and a truck driver who had come to unload slaughterhouse waste. The high concentration of H₂S in the facility complicated the fire department's rescue operations. Roughly a dozen firemen were intoxicated to

varying degrees. Extensive aeration (more than 24 hours) was required before access to the building was authorised. The accident occurred while the truck was being unloaded inside a facility that had been kept closed in order to limit the emanation of foul smells. The load was being dumped into a 100-m³ pit equipped with 2 agitators. The pit's cover could not be closed as the electric actuating motor was out of service. The materials being unloaded were essentially pork entrails, viscera and liquid wastes having high sulphur content, pH near 8.5 and temperature of 60 °C. The waste had been loaded into the truck 24 hours earlier and was similar to wastes generally delivered by the slaughterhouse once to twice per week. The reaction between these substances and the material already present in the pit (animal and dairy wastes having a relatively low pH as determined by analyses performed after the accident) generated the release of H₂S. The temperature of the environment and the agitation of the mixture promoted the dispersion of toxic gas throughout the unloading facility. To make matters worse, the extraction system at the bottom of the pit, which directs the foul air to the outside via a biofilter, proved to be insufficient.

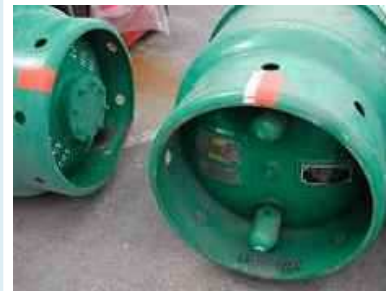
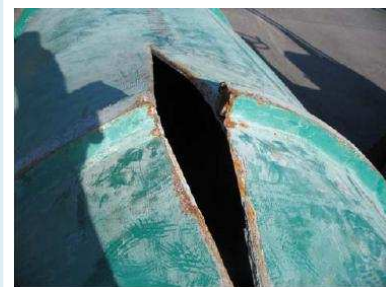
An expert evaluation noted that the pressure equipment ruptured as a result of overfilling attributable "inappropriate" operating procedures and recommended that drums be systematically weighed. According to the CII (Classified Installations Inspectorate), the procedure is particularly difficult to perform: careful positioning of the "multi-purpose" drum on its side at an angle of 40° so that the 85 or 100% top-up limiting tube can serve its purpose. In addition, these drums are liable to contain liquefied gases or liquids according to 2 marks painted on its side... This setting is nevertheless imprecise as the end of the tube, based on its design, can vary in distance from the wall of the cylinder. The mixing of products (water / NH_3 ...) can also not be disregarded due to the multipurpose nature of the arrangement. Finally, systematic weighing may also be difficult: cramped machine rooms... A room adjoining the machine room and connected to the latter's stack, capable of resisting a heat flux and equipped with an appropriate detection system, shall be built to store the containers. The internal contingency plan has been reinforced. A more formal approach has been taken in developing the mobile tank filling/draining procedures.
